DC TECHNICAL REPORT 52-134

EVALUATION OF INTERFERENCE BLANKER MX-1077(XA)/U

COMMUNICATION AND NAVIGATION LABORATORY

JUNE 1952

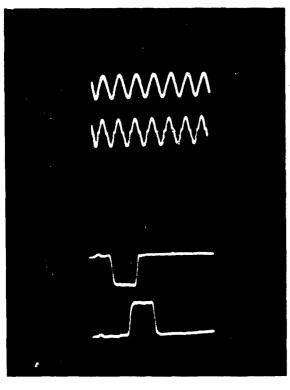
FIGURE 3
SIGNAL CHANNEL INPUT AND OUTPUT

The video channel begins to slice at about 500 millivolts peak input and begins to limit at some point above 600 millivolts. This is well within the specifications which requires no limiting up to 200 millivolts peak input. Apparently, the parallel video stages are driven into a Class C operation with inputs about 500 millivolts peak. The output for a sinusoidal input of 560 millivolts peak is shown in Figure 3.

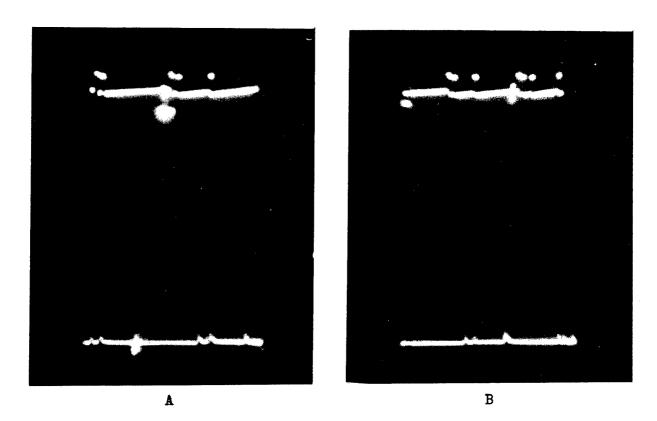
FIGURE 6
PHOTOGRAPHS OF CORONA PULSES AND RESULTING BLANKING PULSES

Simultaneous 125 us sweeps showing blanking pulses on the top traces and the causative corona pulses on the bottom traces.

Several deficiencies can be noted from the photographs. Perhaps the most serious fault is the narrowing of the blanking pulses. The effect of this pulse narrowing will be fully discussed in the paragraphs concerning the constant repetition rate pulse-pair tests.

Another defect can be noted in Figure 6A which illustrates that the blanking pulse generator did not fire for an isolated corona pulse of considerable amplitude. The MV sensitivity control was not set at a maximum; however, it can be seen from the picture in Figure 6B that the multivibrator was firing on very much smaller pulses at higher repetition rates. The seriousness of this "sleeping sickness" depends upon the frequency with which it occurs. Only a few such instances were observed, but it must be remembered that only a small percentage of the total time was sampled. This condition could not be analyzed because of the scarcity of its occurrence but is hereby reported for future reference.

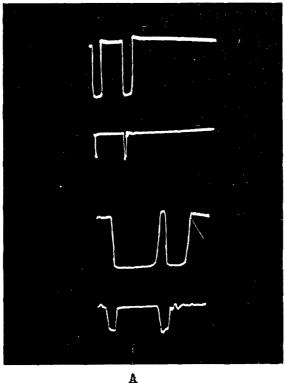
FIGURE 9
CLOSELY SPACED PULSES AND RESULTING BLANKING PULSES

Results of tests with the above-described input pulses are shown in Figure 9. Figure 9A shows triggering pulse-pairs and the resulting blanking pulses. Traces 3 and 4 of Figure 9A display the pulses on a 5 microsecond sweep, and it can be noted that the second blanking pulse has narrowed considerably as the interval between the pulses is decreased.

Figure 9B shows the unblanked output of the Blanker superimposed on the blanking pulse and blanked output of the Blanker for two different intervals between input pulses. The oscillations present near the second pulse of the output waveforms are due to radiation from the Hewlett-Packard Pulse Generator and should be discounted. Traces 3 and 4 show the input pulses spaced so as to give two close spaced blanking pulses. The second pulse is narrow and the effect of this narrowing is evident in the output waveform which shows that the trailing

- 1. Unblanked Output superimposed on Blanking Pulse.
- 2. Blanked Output Sneak-Through.
- 3. Unblanked Output Superimposed on Blanking Pulse and Foreshortened 2nd B.P.
- 4. Blanked Output Sneak-Through.

- 1. Completed Blanking Pulses on 25 us Sweep.
- 2. Trigger Pulses.
- 3. Close Spaced Blanking Pulses on 5 us Sweep, Showing Foreshortening.
- 4. Trigger Pulses for Trace 3.

edge of the interfering pulse was left unblanked. The same result is evident in traces 1 and 2 where the input pulses are spaced so that only a single, normal width blanking pulse is generated. If the pulses had been spaced a little closer than shown on trace 1, they would both have been blanked out by the single blanking pulse. If they had been spaced a little further apart than shown on trace 3, the second blanking pulse would have been sufficiently wide to blank the second interfering pulse. It is during this small interval in time on the horizontal axis, that the blanking pulse generator is incapable of blanking out the entire pulse. This invalidates the blanking action for the given noise pulse and results in unwanted effects in receiver. Further evidence of this is given in Appendix C where the coincidence stage is discussed.

The pulse channel of Interference Blanker MX-1077(XA)/U is not acceptable since Paragraph 3.3.8.4 of Exhibit No. MCREE-685 requires that the width of the blanking pulse be automatically extended upon the arrival of other triggering pulses before the completion of any blanking pulse.

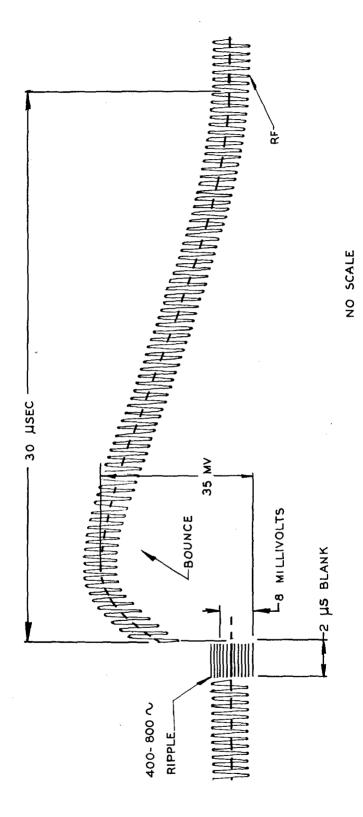
SKETCH OF APPROXIMATE AMPLITUDE AND SHAPE OF BLANK AND BOUNCE

Figure 11 shows the resulting wave shape at the output of the blanker. This figure was sketched from the DuMont Oscilloscope Model 248A (248 scope) and Tektronix Pre-Amplifier Type 121 (pre-amp 121).

It has been found that the bounce under corona conditions can be reduced in amplitude to approximately 20 millivolts by appropriate decoupling measures such as shown in Figure 12, but the resulting residuals were still too great to meet specifications. Figure 13 shows that when two successive pulses appear within 50 to 20 microseconds of each other, the bounces are additive so as to increase the residuals to approximately twice the previous conditions when only one pulse was present.

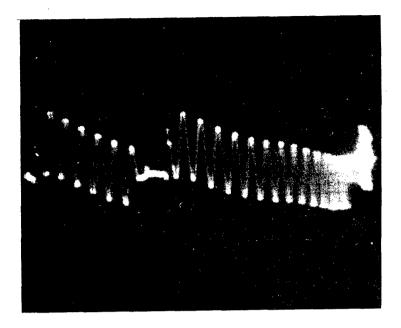
FIGURE 15

The noise pulse blanked out was within the 200-millivolt maximum range specified. Above that amplitude at constant repetition rate to the blanker, the ride-through (that portion of the noise pulse which may appear during the blanking interval) becomes apparent. The single sweep pictures taken from the 248A scope screen bear out the fact that ride-through was present but generally less than the amplitude of the maximum residuals. See Figure 15.

RF: 20 mv peak to peak SWEEP: 25 Microseconds CARRIER FREQ: 1 Megacycle

RIDE-THROUGH DURING THE BLANK

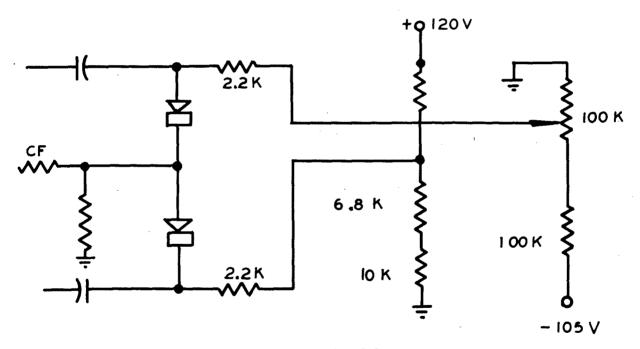
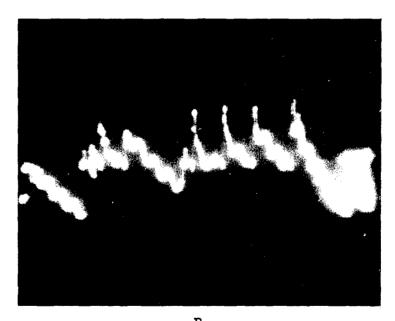
FIG. 16
(REFER TO FIGURE TEN)

the blanker connected to the input of the receiver (with the blanker crystals cut off as stated above) the S-Meter indicated SS showing that there is apparently considerable feed-through. Figure 16 shows both battery and bleeder methods used in biasing the crystals.

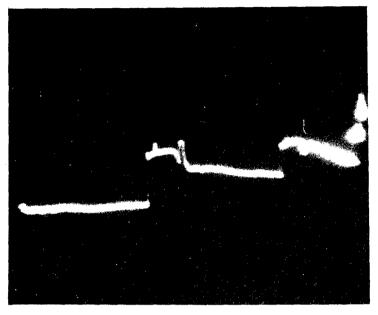
FIGURE 17
SINGLE SWEEP OUTPUT OF COINCIDENCE STAGE

Figures 17A and 17B illustrate the retatively large composite residuals of magnitudes of from 40 to 50 millivolts. This decidedly shows the unsatisfactory operation of the blanker.

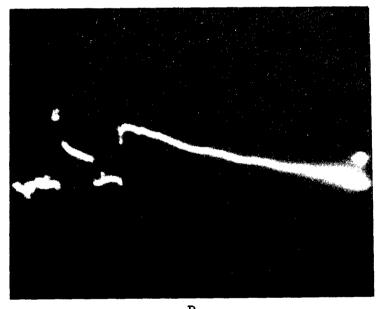
B
FIGURE 18
SINGLE SWEEP OUTPUT OF COINCIDENCE STAGE

The output of the coincidence stage is shown in Figure 17 and 18. The transients are a result of the deficiencies in the coincidence and pulse channel operation. Figure 18A illustrates the output of the blanker with apparent results of deficiencies as listed below:

- 1. "Ride-through" during the first blanking interval.
- 2. First blank extended but not sufficiently to cover second noise pulse.
- 3. Second blanking pulse riding on the "bounce" of the first blank.
- 4. The first blank riding in the trough of a bounce caused by a previous blank.

The residuals shown are approximately 20 millivolts peak.

Figure 18B shows the same results as in Figure 18A except that the blanking axis is at a lower level in respect to the mean r-f level. This may be a result of blanking axis shift caused either by the a-c pickup variation as discussed previously, or by change in repetition rate of the noise source.
